**Draft Situation Assessment Report:  
Seekoei Estuary  
January 2018**

# Draft Situation Assessment of the Seekoei Estuary

**Institute for Coastal and Marine Research**

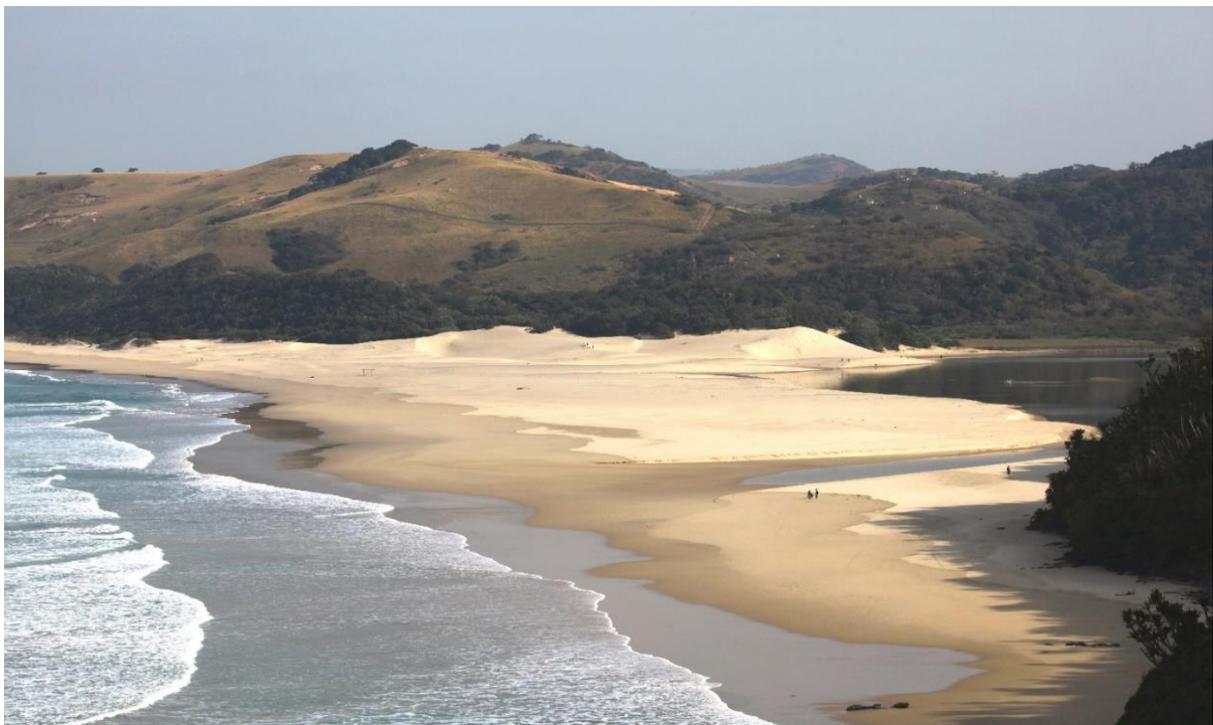
**Plate 1** The Temporary open/closed Mgazi Estuary (a short distance south of Port St Johns) a few days before final winter mouth closure. Typically, water levels in the estuary would slowly build up and with the onset of summer rains or a flood, breach the sandbar at the mouth and remove much of the accumulated marine sand. Natural breaching of an estuary mouth maximizes the probability of the mouth remaining open for longer compared to a premature artificial breaching event at a lower water level.

Associated with variability in estuarine salinity (that may range from near-zero to >35) is the state of the mouth, varying from wide open to fully closed with the development of a berm (Plate 1). Occasionally, the mouth may remain closed for extended periods (years) if river runoff remains low. Under closed mouth conditions, water movement driven by tidal action obviously ceases and wind becomes the main driver of water mixing. Under conditions of mouth closure, salinity in the estuary may decrease progressively if low freshwater baseflows persist. If evaporation rates from the estuary exceed the volume of freshwater inflow from the catchment over time, then salt concentration in the

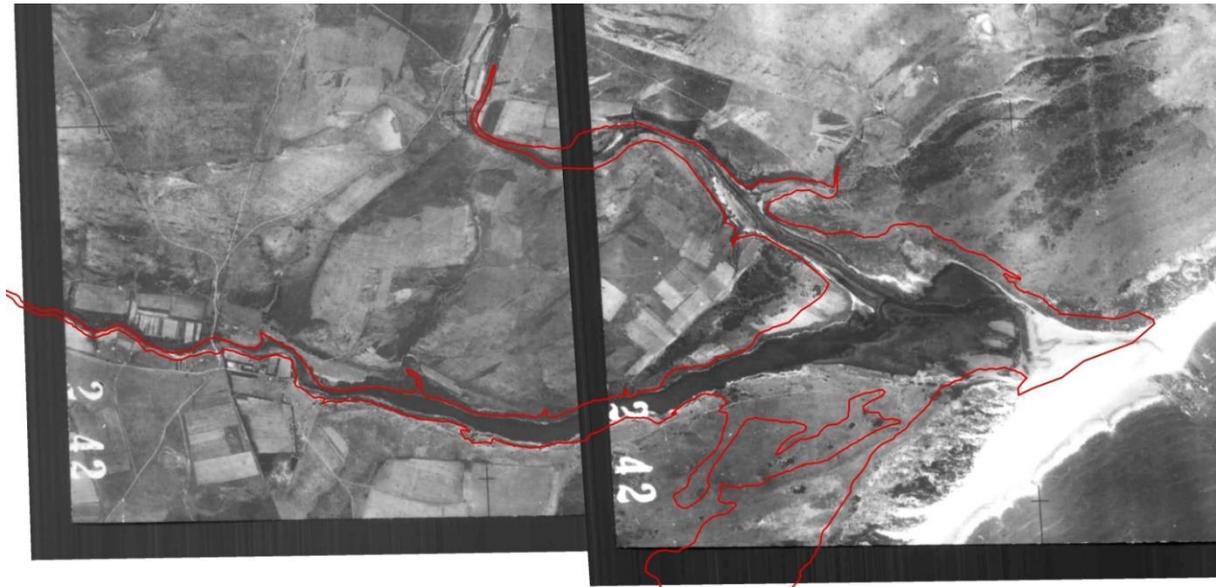
**Figure 3** Aerial survey images of the Seekoei catchment in 1942, the 5 m contour line around the estuary is outlined in red.

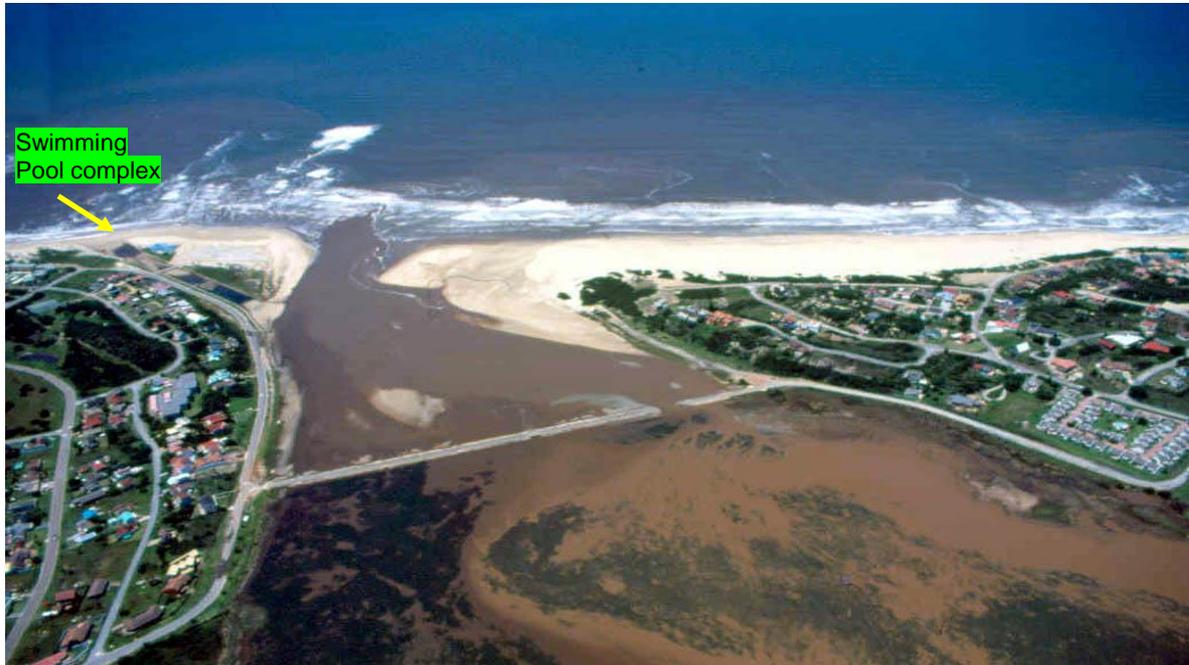
**Plate 2** At the time of this photograph (~mid 1980's), the original rubble causeway had been breached and floodwaters eroded a relatively deep and wide channel. The photograph also shows a plume of discoloured estuarine water radiating from the mouth – refer to Figure 5 (Photograph from T Wooldridge).

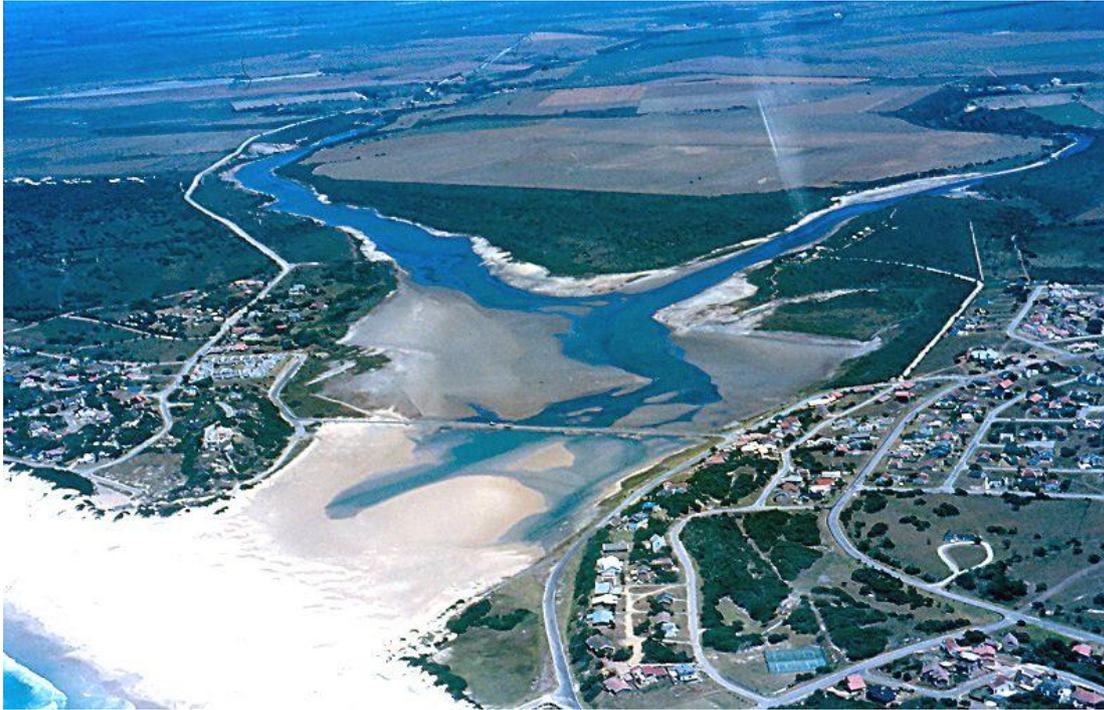
**Plate 3** View of the Seekoei from mouth to catchment area, demonstrating the separate channel basins at the mouth area. Photograph from T Wooldridge.

After the construction of the causeway, the Seekoei Estuary was split in to two separate units that essentially blocked tidal flow from reaching up-estuary (Plate 3). More recently, alterations were done to improve the connectivity between the two water bodies. Although it was originally predicted that the upper estuary would become fresh (Esterhuysen 1982), water abstraction from the catchment has become excessive and the estuary now receives a much-reduced supply – refer Sections 6.1 and 6.5. Occasional floods are also important to remove accumulated sediment, but the barrier effect caused by the causeway reduces scouring. These floods are an important part of a natural cycle in that they also remove large quantities of marine sand that accumulates through tidal transport, overtopping of the sandbar and aeolian transport. Note the extensive area of farming activity north of the Seekoei River Nature Reserve and surrounding the two tributaries (Plate 3).

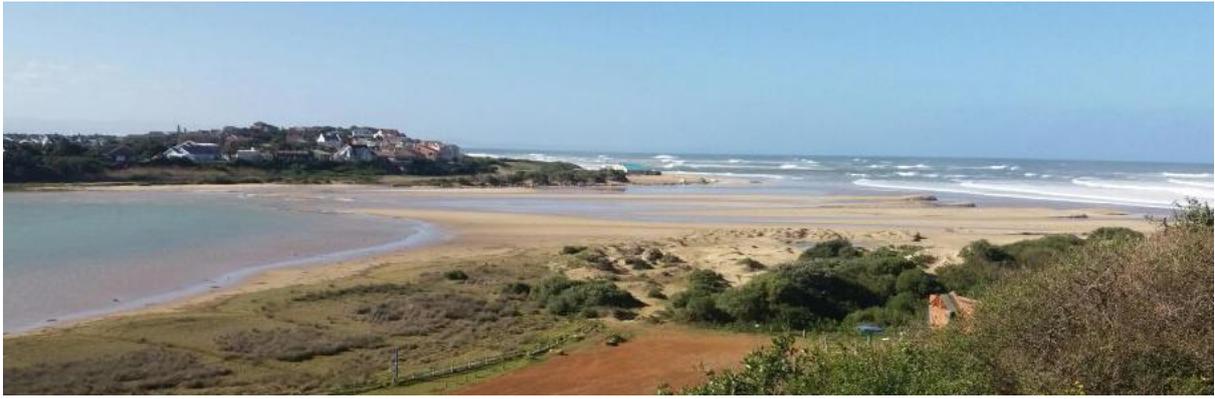
**Plate 4** The low height of the berm can be clearly seen in the photograph above. The photo was taken during the spring tide cycle and three hours before the peak of high tide on 24<sup>th</sup> June 2017.

The low berm height was still evident in June 2017 (Plate 4). Information suggests that overtopping of the berm by wave action occurs under storm conditions, particularly if they coincide with spring tides. Numerous records are available indicating flattening of the berm by wave action is intermittent, linked to storm events. The photograph below was taken on the 24<sup>th</sup> June at approximately 1 pm and two days after New Moon. At the time, no riverine input to the estuary was evident. Water volume in the estuary was probably maintained at the observed high level by berm over-wash of seawater. Salinity at the time was 46 immediately above the causeway. Hypersalinity has persisted throughout 2017. In March 2017, another fish kill was reported (Renzo Perissinotto of the Nelson Mandela University, pers. com.), with many dead fish and invertebrates washed up around the edge of the estuary.

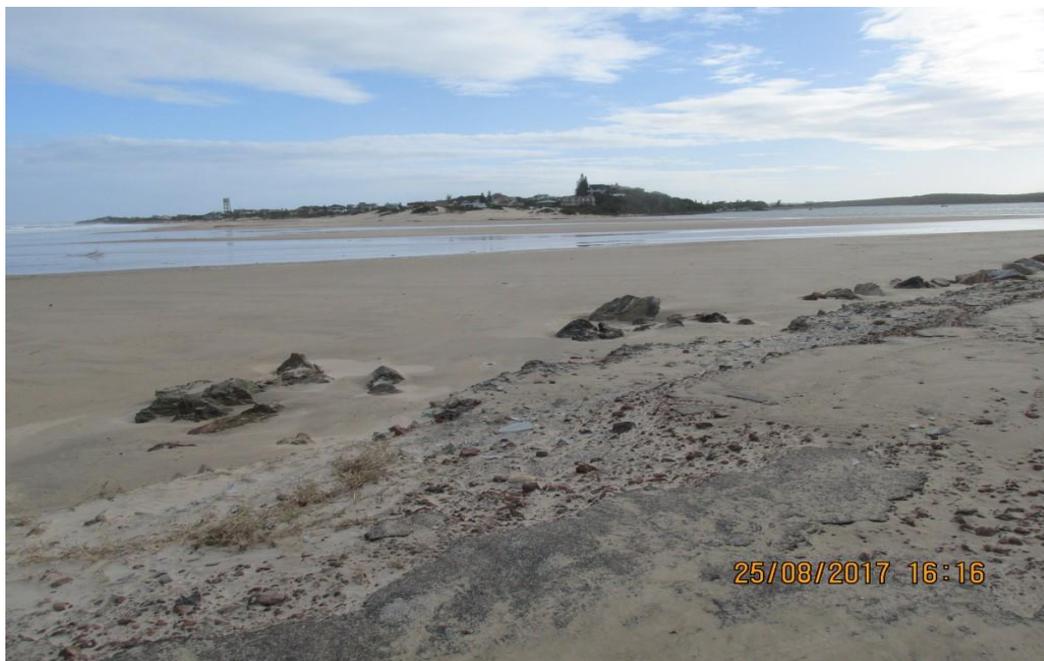
**Plate 5** The low berm level present on the 24 and 25<sup>th</sup> August 2017 is clearly evident. Photo by Hennie Swanevelder – Department of Economic Development and Environmental Affairs.

A further overtopping of the berm occurred on the 24<sup>th</sup> August 2017. The event happened shortly after spring tides. A major storm sweeping across the south coast at the time (Plates 4 – 8).

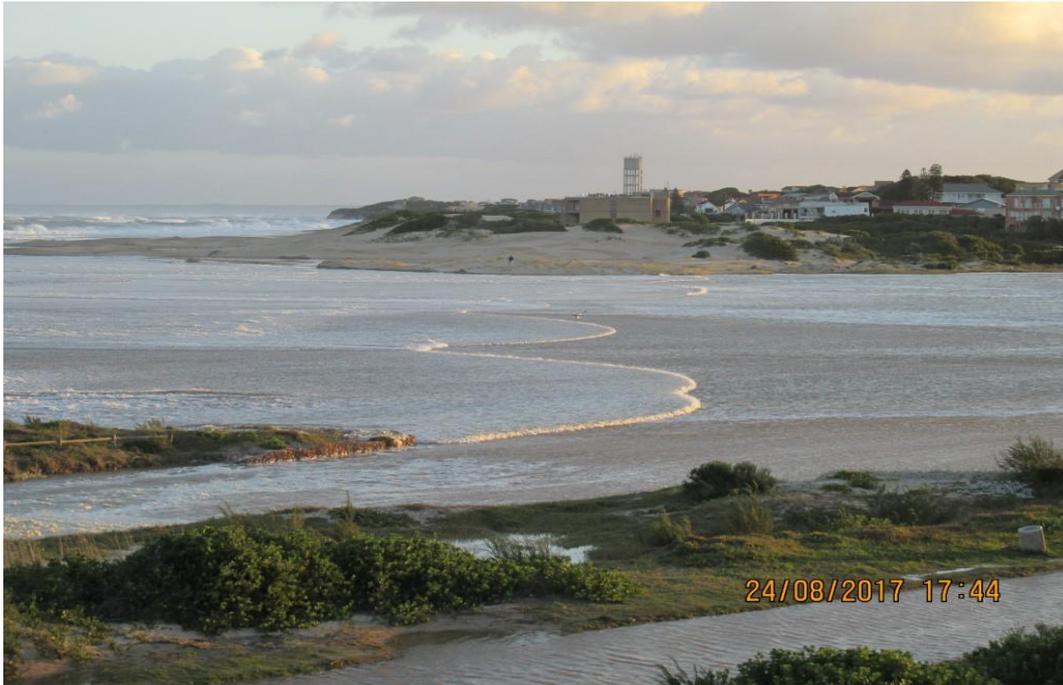
**Plate 6** Berm overwash occurred around high tide on 24 August 2017. The estuary was rapidly filled, with the tide also overflowing the causeway. Depth of the water across the berm peaked at about 40 – 50 cms. During such events, large quantities of marine sand are deposited in the estuary. Photograph from Hennie Swanevelder – Department of Economic Development and Environmental Affairs.

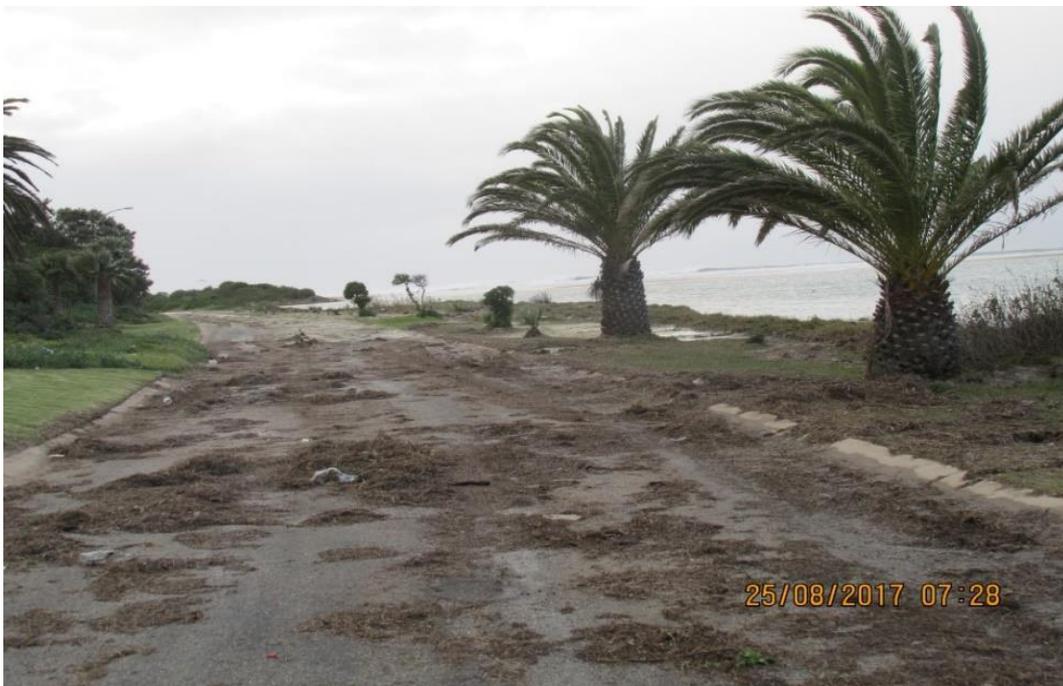
**Plate 7** Berm overwash shown in Plate 6 deposited large quantities of flotsam on the Aston Bay road running parallel to the estuary. Photograph from Hennie Swanevelder – Department of Economic Development and Environmental Affairs.

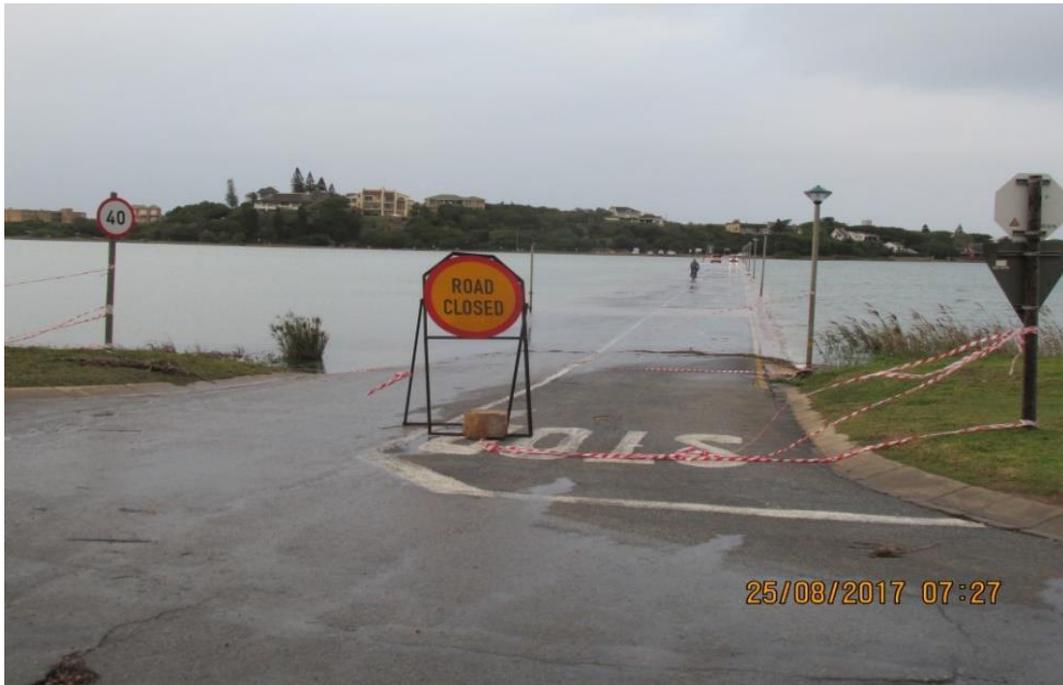
**Plate 8** Berm overwash shown in Plate 6 resulted in the causeway overtopping with seawater. Zero freshwater inflow to the estuary occurred around this time, so that salinity levels in the estuary would remain at 35 or higher. High rates of evaporation would rapidly result in hypersaline conditions developing in the estuary as the estuary closed again within 48 hrs. Photograph from Hennie Swanevelder – Department of Economic Development and Environmental Affairs.
